Chromatic reintegration: Color Matching Challenges in Polychrome Wooden Ceilings

This paper presents a comprehensive study on the materials, manufacturing techniques, and conservation strategies used in the polychrome wooden ceilings and walls of the Church of Santa María de Cuevas in Chihuahua, Mexico, whose origin dates back to Spanish colonial times. It focuses on the chromatic reintegration process and the significant findings discovered during the restoration project. The renowned Italian technique of *sottotono* (lower color tone) was employed to establish color reintegration criteria, allowing for a clear distinction between restored and original paint in the ceilings situated 12 meters above the floor. The varying intensities of the original paint posed challenges, particularly in beam ceilings where achieving smooth variations was not feasible. Floral decorative motifs exhibited a consistent red-orange hue, while yellow displayed variations, especially in areas affected by water damage. The blue color, prominent throughout, exhibited notable variations in hue, with two different saturations observed. The restoration process revealed unique insights into the design techniq

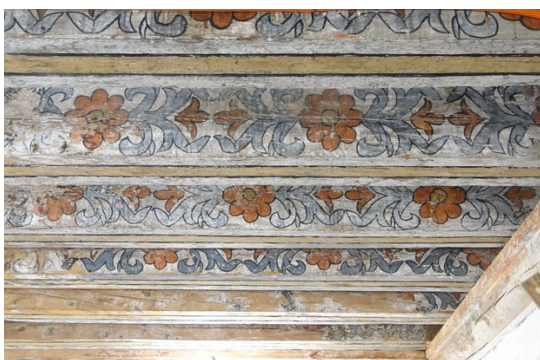
Alternatively, other substrates inert to palygorskite were used: from other clay silicates of capillary nature to calcareous matrices, among others. In the case of Santa Maria studies indicate the use of gypsum as mortar to produced the blue pigment. The central beam lost most paint intensity, while blue on the borders and panels retained its vibrancy. This discoloration, initially thought to be due to window light, was also found on the interior-facing side of the same beam, suggesting other factors may contribute to the fading (Figure 3).

Fig. 3. View of the beams facing window light. It is possible to observed the color blue hue differences between the beams (Photo: Muñoz-Alcocer, K., 2024).

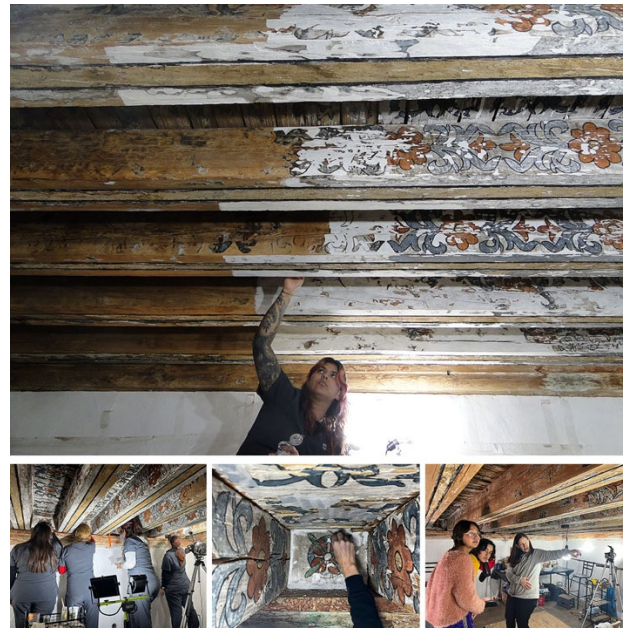
Fig. 4. Conservation treatment application, training & community outreach (Photo: Muñoz-Alcocer, K. & Jaquez Sotelo J., 2024).

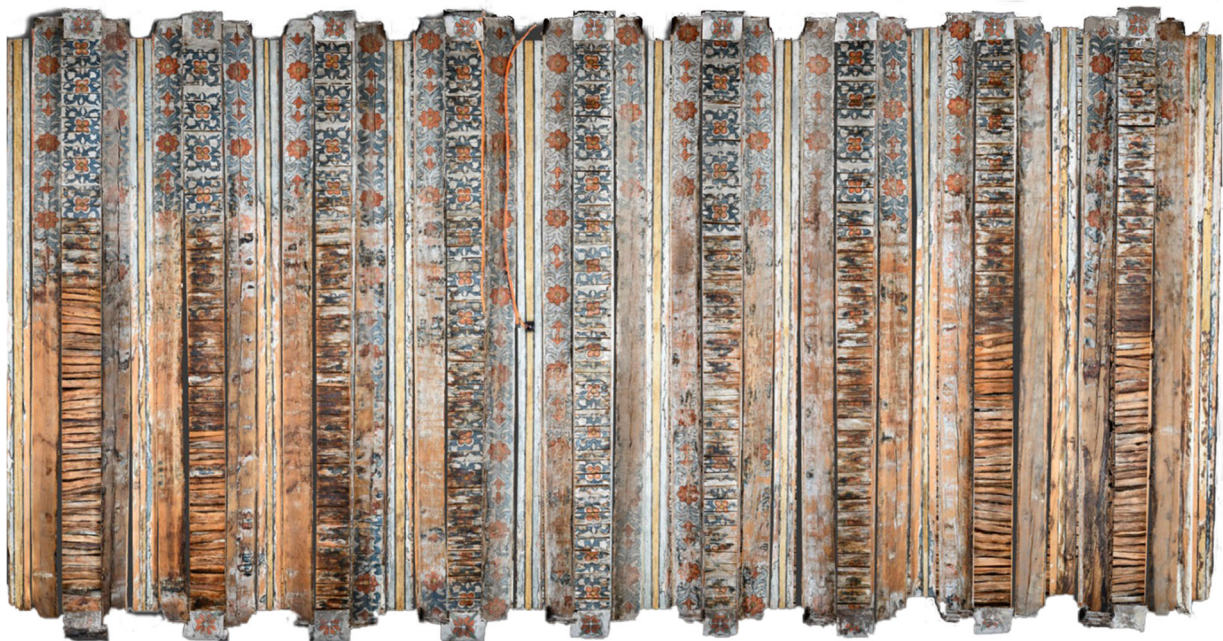
The digital images provided a perspective view of the ceiling and, through software, a flat view of the ceiling, a mapping of the structure and state of preservation of the pictorial layers and, for the purposes of this paper, the color degradation (Figure 5).

Fig. 5. Photogrammetry image of the ceiling before the intervention. It is possible to observe the three face-sides of the beams. Note the blue color tone variations between the beams, including at beam-face that is not exposed to light. (Photogrammetry & imaging: Misiones Coloniales de Chihuahua A.C., Montes Treviso F., 2024).

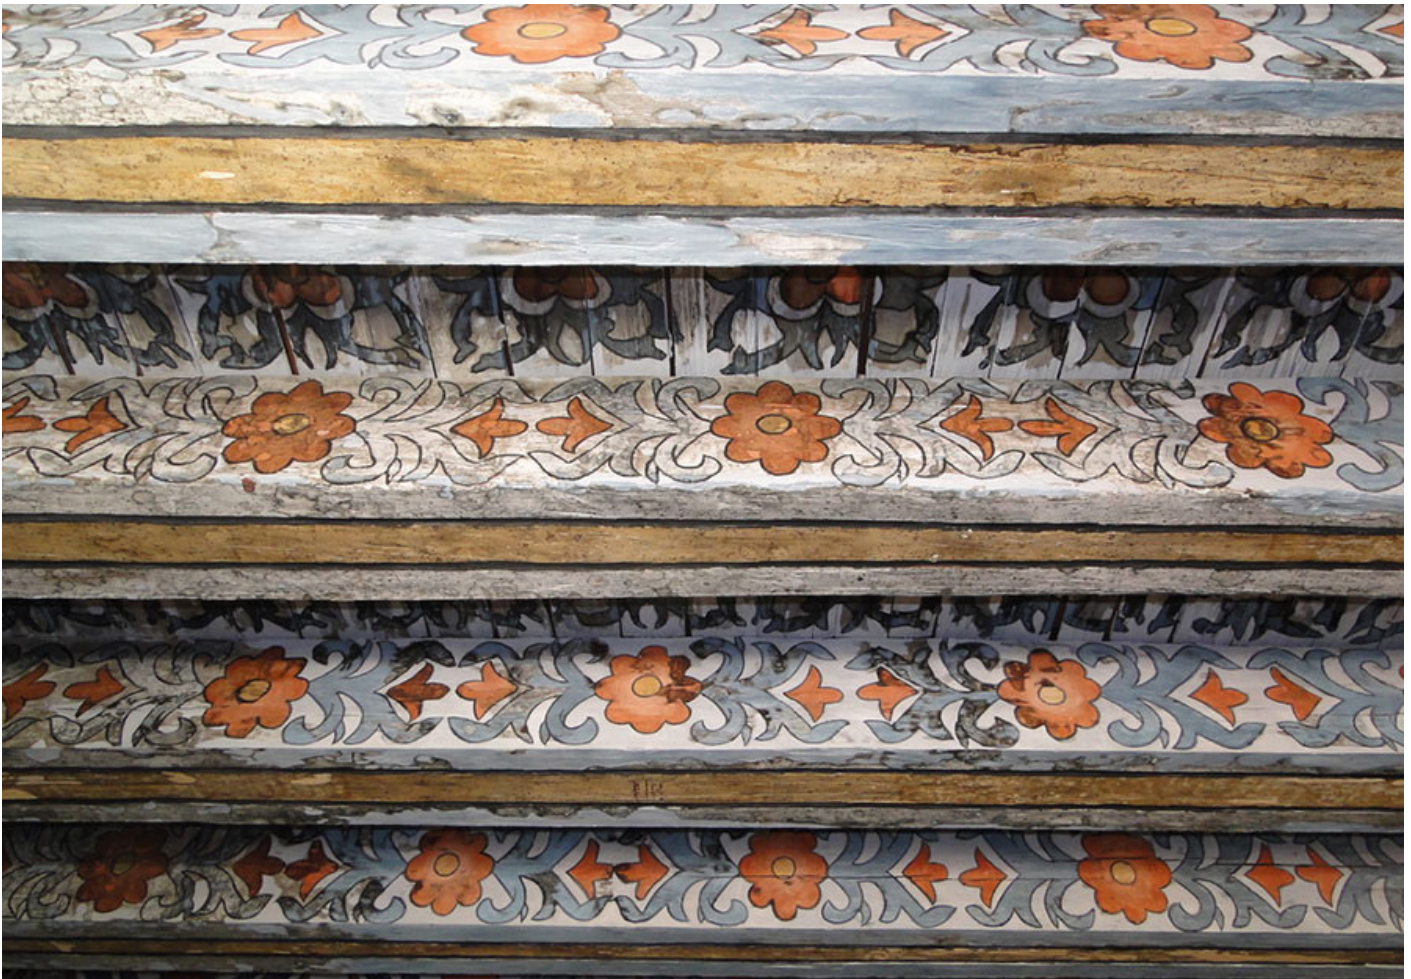
Fig. 8 View of the beams after the color correction. Note that the same blue hue was used for the chromatic reintegration, despite the difference in the hue of the original paint (Photo: Muñoz-Alcocer, K., 2024).

The color correction was achieved through the use of a spectrophotometer. The dark blue of the panels served as a base color to determine the correct hue, which was then applied as a neutral tone, even in the lighter or more transparent blue sections. Although the selected hue was stronger than the original light blue or gray-white areas, adjusting the saturation allowed for a uniform appearance from any viewpoint on the ceiling (Figures 7 & 8).

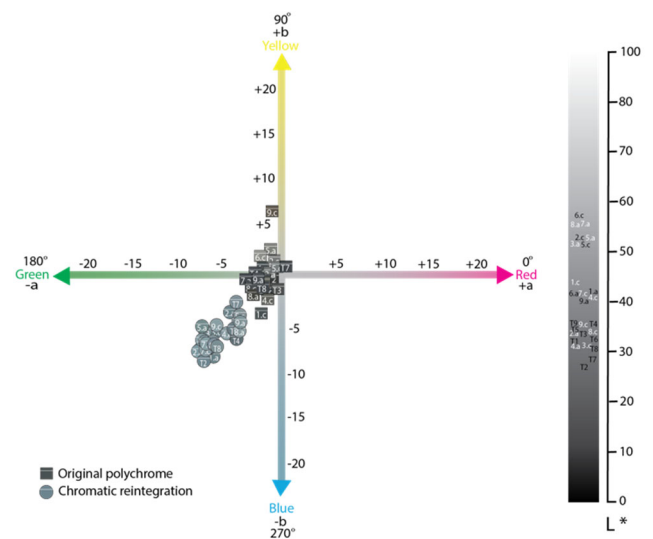
The readings from the spectrophotometer were analyzed in the CIEL*a*b* color space for the 10° Supplementary Standard Observer and D65 Standard Illuminant. As reported in the L*a*b* diagram (figure 9), the colorimetric data allowed us to confirm that the blue hue of the panels (T) has lower luminosity (L). The beam sides facing natural light (a) and those facing the interior of the room (c) presented interesting results. Although the chromatic values (a* and b*) were almost identical, it was the luminosity (L*) that differentiated these groups. The 'a' sides, closer to the window, exhibited higher L* values, while the 'c' sides had lower values. However, beams 2.c, 5.c, and 6.c showed the same L* values as the beam sides exposed to natural light (3.a, 5.a, 7.a, 8.a). This suggests that light is not the only factor influencing the hue degradation of the blue color; it may also be related to the method of application and the skill of the painter.

Fig. 9. Diagram of CIELAB color chart with the L* a* b* resulted from the original paint and the chromatic reintegration (Muñoz-Alcocer, K., 2024).

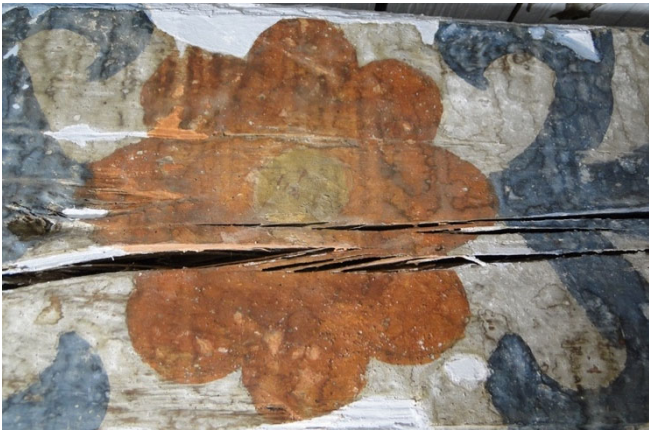
The restoration process allowed for a detailed examination of the polychrome materials and design of the ceiling, revealing the involvement of multiple artisans. While the overall design was applied using a stencil technique, the botanical elements, such as flowers and leaves, were hand-painted and outlined. Variations in the design were observed, including differences in starting points and omissions, with some areas missing black outlines, suggesting that the work may have been left unfinished (Figure 10).

Fig. 10. Detail of the decorative flowers on the panels. Notice the absence of black lines (Photo: Muñoz-Alcocer, K., 2024).
